REPAIR, EVALUATION, MAINTENANCE, AND
REHABILITATION RESEARCH PROGRAM

TECHNICAL REPORT REMR-CO-1

STABILITY OF RUBBLE-MOUND
BREAKWATER AND JETTY TOES;
SURVEY OF FIELD EXPERIENCE

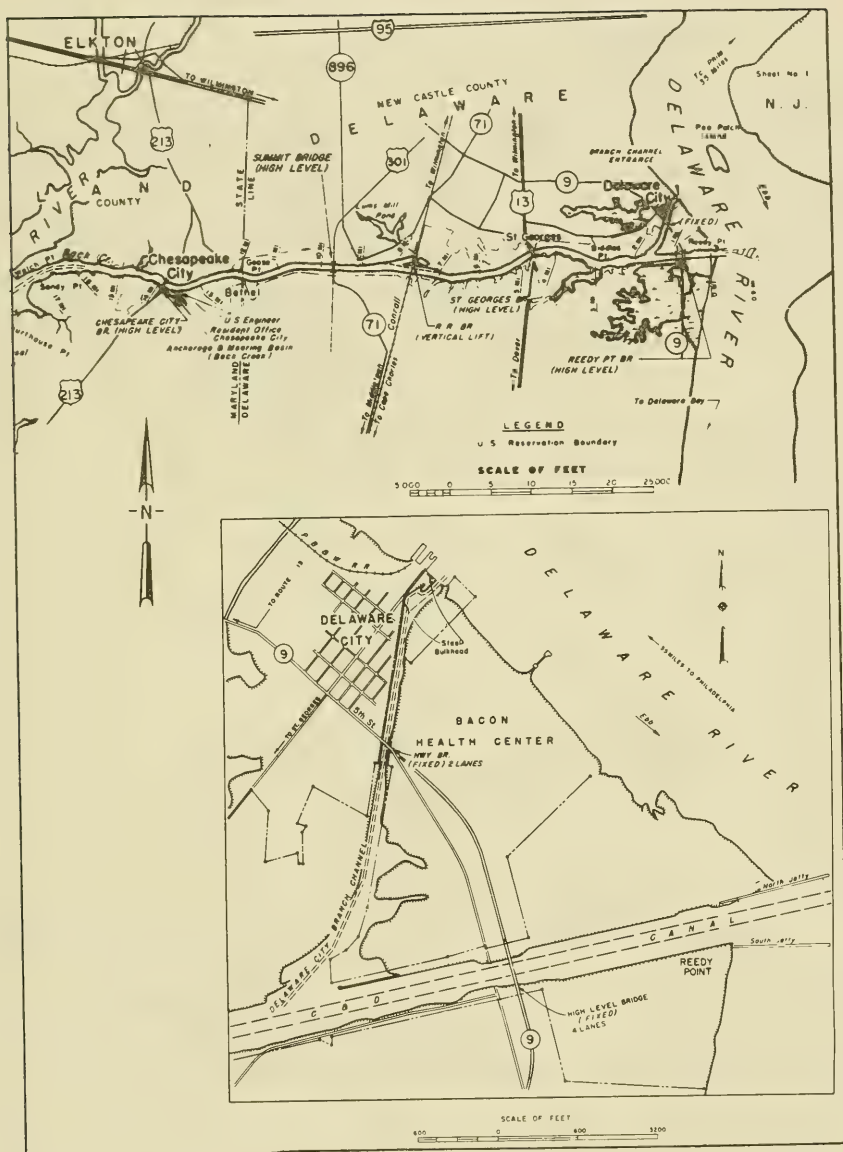
Figure 28. Reedy Point Jetties, Delaware

26. The jetties located at Reedy Point, where the Chesapeake and Delaware Bay Canal intersects the Delaware River, were originally constructed prior to 1938 (Figure 28). Both structures were of rubble-mound construction. In the 1960's the existing south jetty was removed, and a new south jetty was constructed farther south. This was done to increase the entrance size to accommodate larger vessels and improve navigation safety. The present jetties are both 2,095 ft long, and it was reported that the north jetty has problems with toe scour, loss of armor stone, and overall subsidence.

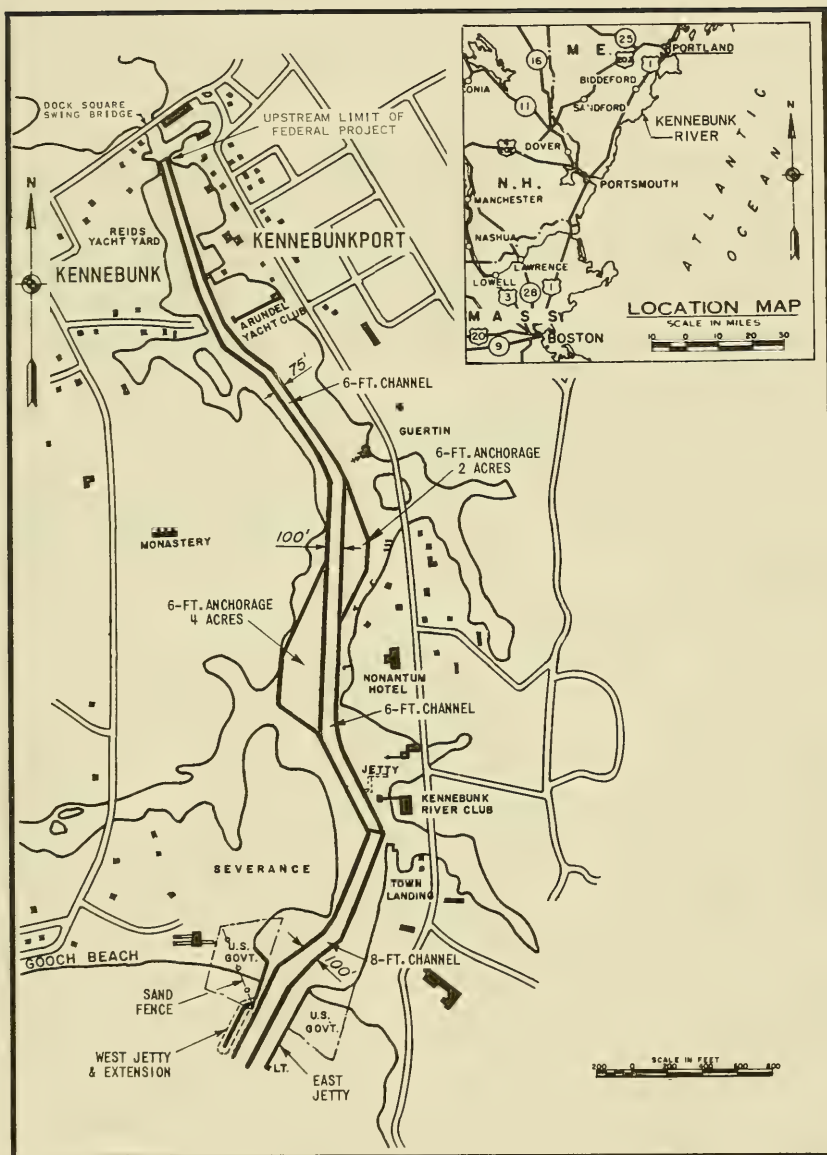
Figure 30. Kennebunk River Jetties, Maine

28. Based on review of historical repair data, it appears that three project sites within the New England Division that contain rubble-mound jetty structures have exhibited stability problems which could be related to instability of the structure toes. Both jetties at the mouth of the Kennebunk River, Maine (Figure 30), have a history of extension and repair. The latest jetty rehabilitation work was completed in 1982. Recent inspections show that both jetty heads are damaged and that 250 ft of the channel side of the east jetty have been undermined. The most recent inspection reports (1973-74), indicate that the north and south jetties at Newburyport Harbor, Massachusetts

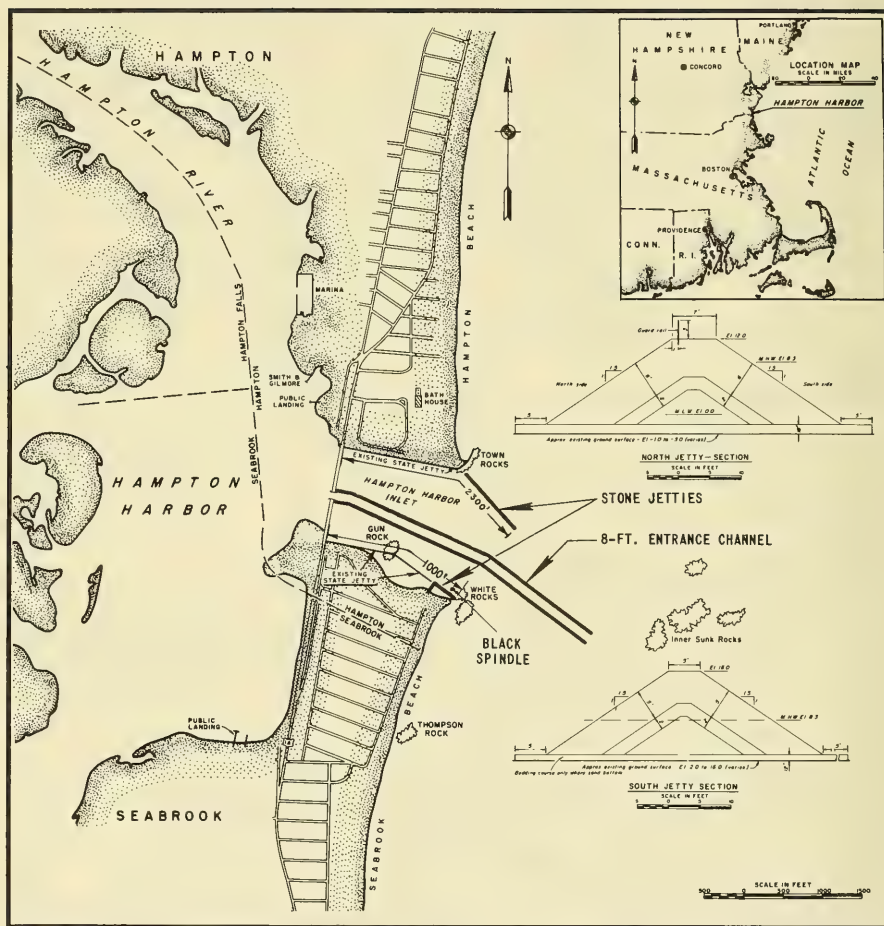
Figure 32. Hampton Harbor Jetties, New Hampshire

(Figure 31), which have an extensive repair and rehabilitation history, are showing considerable damage. This damage appears to result primarily from subsidence. Damage on four areas on the channel side of the south jetty most likely result from undermining of the rubble toe. The jetties at Hampton Harbor, New Hampshire (Figure 32), were originally constructed by the State and were turned over to the Corps in 1964. During 1965 to 1966, considerable work was done on both jetties. Since that time the south jetty has remained in good condition, while the north jetty has required continuous maintenance. Most of the repair and rehabilitation work has been needed on the seaward portions of the north jetty. The last rebuilding of the north jetty was completed in 1980, and it is thought that part of this recurring damage can be attributed to scour and undermining of the jetty toe.

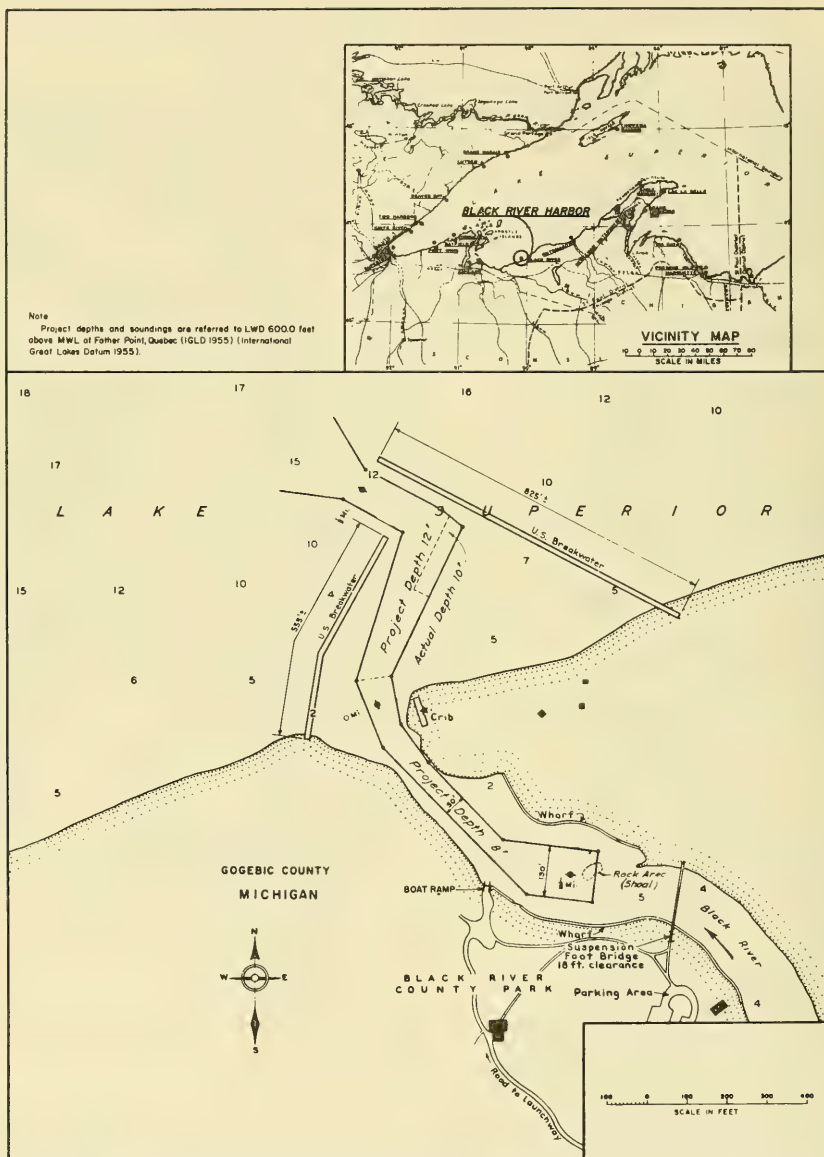
Figure 33. Black River Harbor Breakwaters, Michigan

30. Structures at Black River Harbor, Cheboygan Harbor, Hammond Bay Harbor, Harrisville Harbor, New Buffalo Harbor, and Point Lookout Harbor, Michigan, are purely rubble-mound construction (Figures 33-40). Charlevoix Harbor, Michigan; Duluth-Superior Harbor, Minnesota and Wisconsin; and Leland Harbor, Muskegon Harbor, Pentwater Harbor, Port Washington Harbor, and Traverse City Harbor, Michigan (Figures 41-55), have structures that are composed of a combination of rubble mound, timber cribs, timber piles, steel sheet piles, concrete caissons, steel cells, concrete caps, and concrete superstructures. The head of the east jetty on the north end of the Keweenaw Waterway, Michigan (Figures 56 and 57), is an old timber crib which is encased in rubble. For this reason, its response is very similar to that of a purely

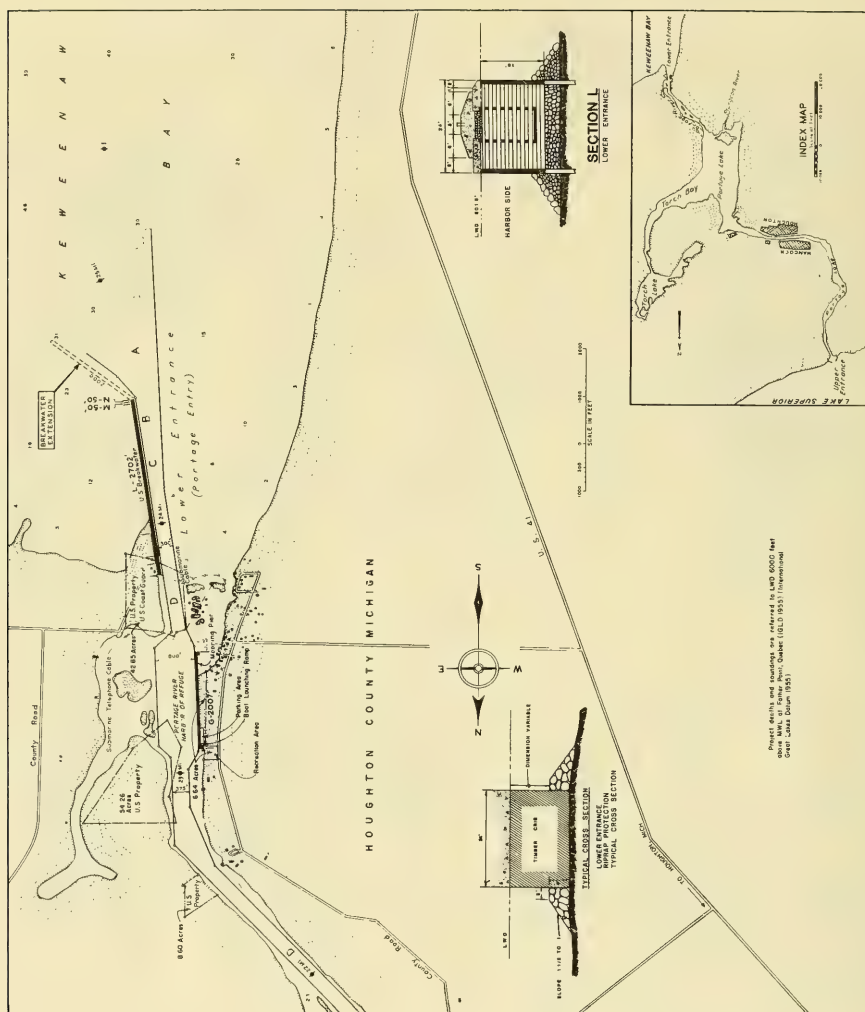
Figure 56. Upper Entrance Breakwaters, Keweenaw Waterway, Michigan

rubble-mound structure. The remainder of the structures at Keweenaw are timber crib with some rubble and steel sheet piles.

31. In general, the rubble-mound structures in the Detroit District that show toe stability problems have shown the results of this problem through damage to the upper slope and crown armor. It is not known definitely, but it is expected that the toe damage is a combination of toe armor instability combined with foundation scour and undermining of the structure toes. Repair to a structure is carried out by filling the scour holes with stone and then reshaping and repairing the structure's armor stone layer(s). Some repairs have been successful thus far, while other areas require frequent repair work.
